# China National Center test-Interior application in Cold Climate

**Subject: Result of CeraTherm Demo Project in Beijing**

# China Exterior Summer

## 2008 Conducted by: Center for Energy-saving Research School of Architecture Huanan University of Science and Technology Guangzhou, Guangdong, CHINA

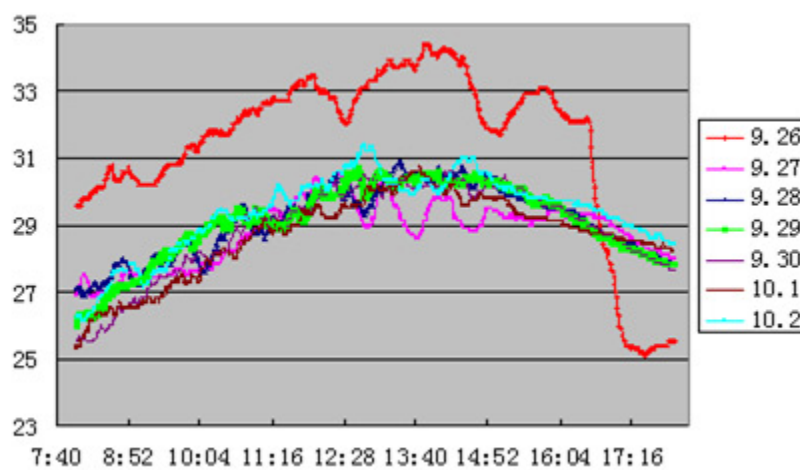
Figure 1 Outdoor Air Temperature during Testing Period  
(Data provided by Wushan Weather Station, Guanghzou, Guangdong, CHINA)

days tested were seven; most days were sunny, occasionally cloudy. Maximum air temperatures outside during the days were all above 30oC.

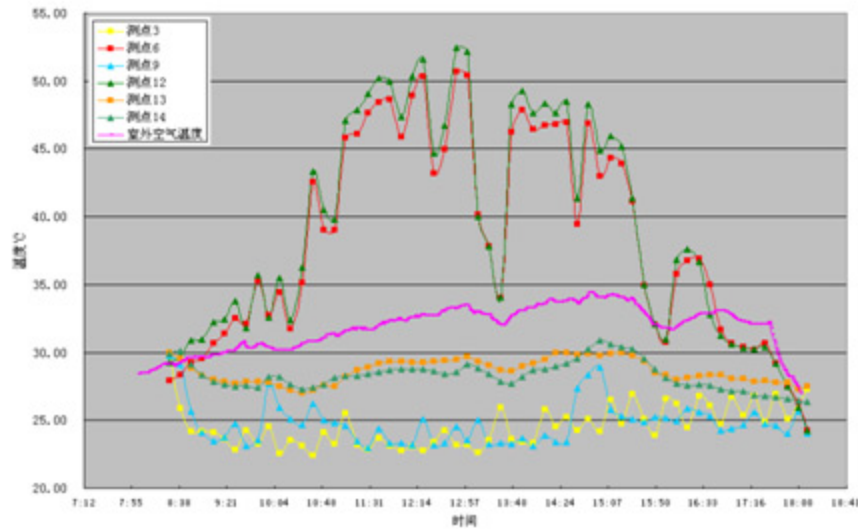
Figure 2 Comparison of Temperature readings at points above and below the rooftop of UR and TR rooms - Sept. 26, 2008

Figure 2 shows the distribution of temperature readings at points both above and below the rooftops of the UR and TR rooms on September 26, 2008. It can be seen that in most cases the outside (rooftop) temperature of the TR room is 0 to 2oC lower than those of the UR's. At 1pm, both the roof and ceiling temperatures were lowered substantially most likely because of the cloud coverage. Because the indoor temperature was controlled by A/C, it resulted in a very small temperature difference between the two rooms. Throughout the testing period, the average indoor temperature of the TR room was 24.56oC; whereas that of the UR room was at 24.80oC; with a difference of 0.14oC. The probes were placed at the same location of its respective room, 1.5m above ground but a bit skewed to the wall where the A/C unit was located. That was the reason why the temperature readings were lower; as compared with the overall indoor temperature, which was in between 25 and 26oC.

Temperature data collected from the thermal probes placed on the rooftops and the southern exterior walls showed that the temperature on the rooftop of the Treated Room was 0 to 2°C lower than that of the Untreated Room; whereas the temperature on the southern exterior wall of the Treated Room was 0 to 1.6°C lower than its counterpart of the Untreated Room. The rooftop and the southern walls are the primary routes for solar rays entering the rooms. When the Treated Room was coated with **CeraTherm**-added paint, it offers a better solar reflection capability than the Untreated Room that was painted with the same paint without **CeraTherm**, as reflected by the lower temperature readings as described just above. When the heat flux into a room is reduced, there upon the electricity consumption from its air-conditioning unit. And this is where the 24.8% energy-saving rate is coming from.

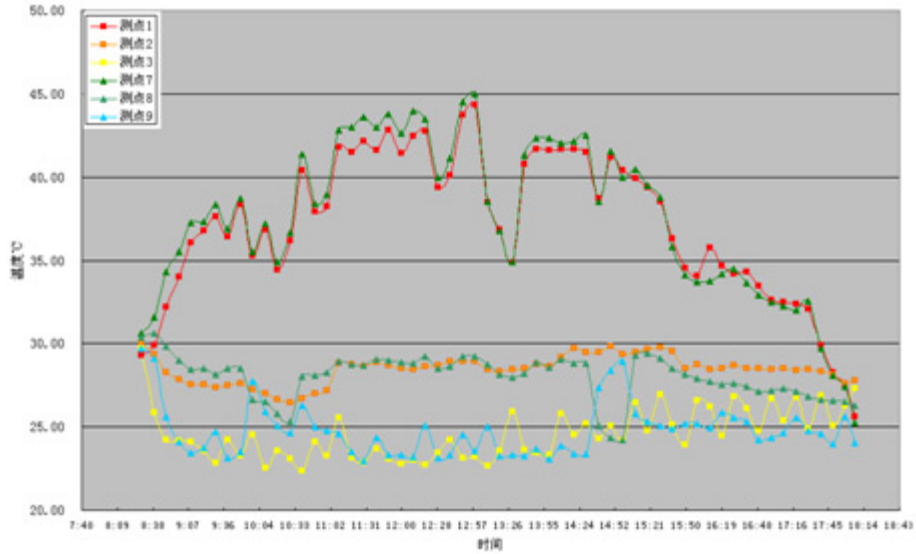
Figure 3 Comparison of Temperature readings on the southern interior and exterior walls of UR and TR - Sept. 26, 2008

Figure 3 shows that the temperature on the exterior southern wall of the TR room is in general 0 to 1.60C lowered than those on the same location of the UR room. The temperatures measured at Probes 2 and 8 do not show a fixed trend, probably was affected by the indoor temperature. The reading on the interior southern wall of the UR room showed a sudden drop at 14:52, which was caused by an unexpected shifting of the air-flow deflector of the A/C unit, thereupon let the direction of the cold air blowing onto the probe directly. The problem was rectified as soon as it had been discovered.

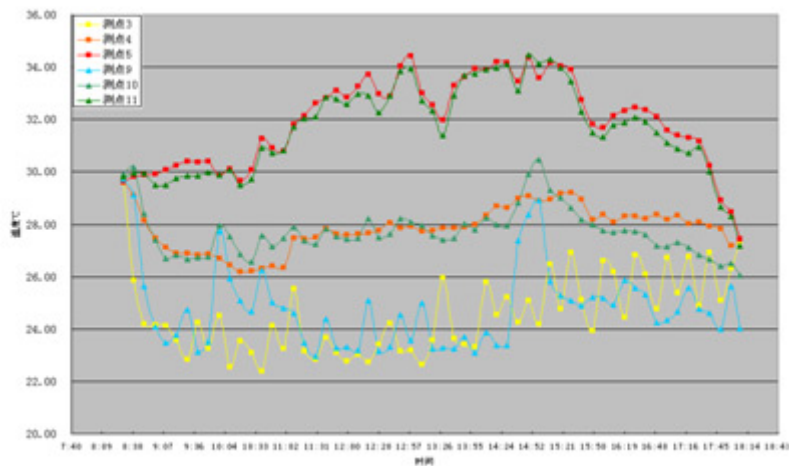
Figure 4 Comparison of Temperature readings on the northern interior and exterior walls of UR and TR rooms - Sept. 26, 2008

Figure 4 compares the temperature measurements on the northern interior and exterior walls between the UR and TR rooms. It seems that the temperatures on the northern exterior wall of the TR room are 0 to 0.80C higher than those measured on the northern

exterior wall of the UR room, most likely due to the fact that there is a semi-transparent plastic awning cover over the northern exterior wall of the UR room where the temperature probe was placed, whereas no plastic cover for the TR room.

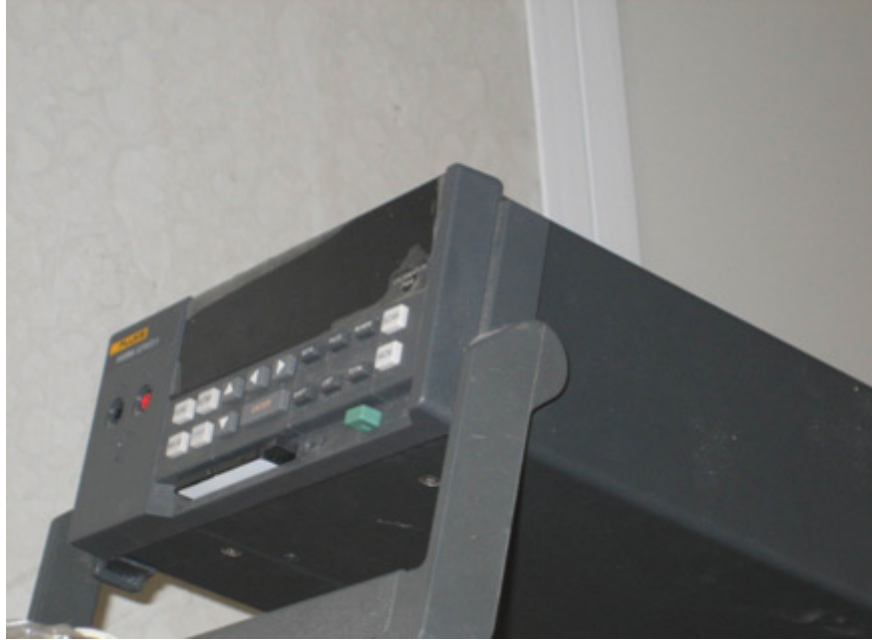
Digital data collection device - Fluke

All instruments and equipment are FLUKE Hydra digital data collection type. All 14 temperature probes are thermal couples.

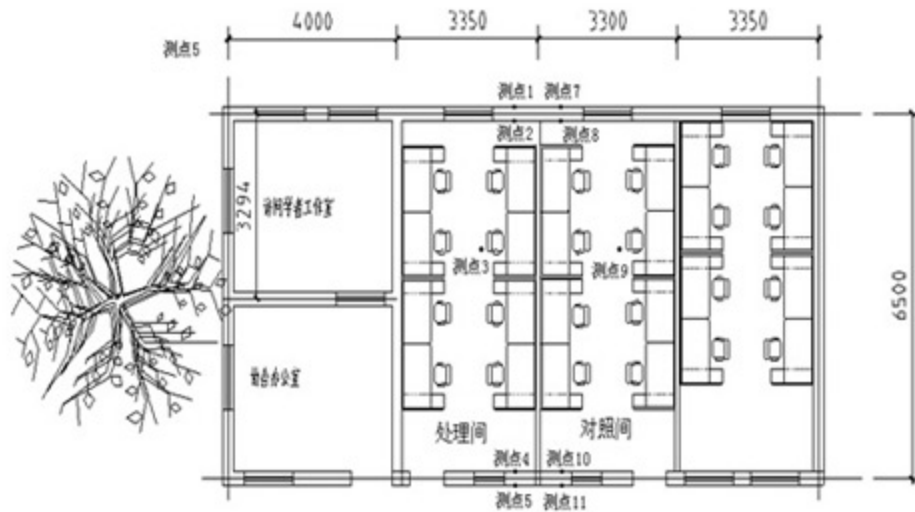
Layout of Thermal Probes (Exterior and Interior walls) - Treated Room is on the left.

Thermal probes for temperature measurement at various points in the rooms are given in Table 1 below. Exact locations of these probes are shown in Appendix 2.

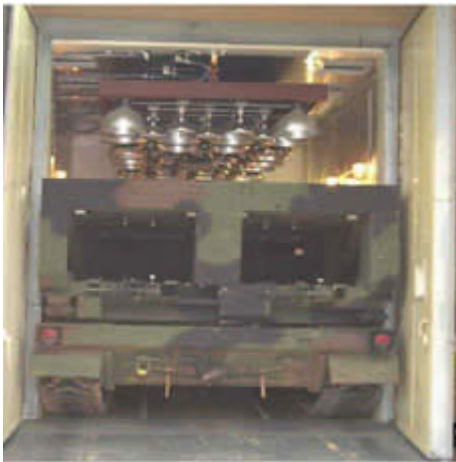
Multiple Launch Rocket System  
(MLRS)

3. The launcher is too large for this chamber to conduct a standard MIL-STD-810 solar radiation test. However, the objective was to determine the effectiveness of the paint additive on the cab area. To accomplish the objective two launchers were subjected to identical solar loading over a two day period. Launcher, S/N 4AA00481, had been painted using **CeraTherm** and launcher, S/N 4AA00222, was not.

5. At every location monitored the cab painted with **CeraTherm** had lower temperatures during the test. On the first day temperatures in the cab peaked at 131.7 F in the launcher with the paint additive and 137.8 F for the other launcher. On the second day the cab temperature peaked at 97.7 F and 100.5 F.
